भारत का राजपत्र The Gazette of India

रेल मंत्रालय
(रेलवे बोर्ड)

S.O. 580(E)—In their Notification No. 77/E(O)II/1/4 dated 30th June, 1977 published in Part II sub-section (ii) of Section 3 of the Government of India Gazette Extraordinary dated 1st July, 1977, Government appointed a Commission of Inquiry consisting of Shri Gangeshwar Prasad, a retired Judge of the High Court of Allahabad as its sole Member, to make an inquiry into the accident involving 13 Up Tezpur Express between Udalguri and Rowta Bagan stations on Rangiya-Rangapara North Section of the Northeast Frontier Railway on 30-5-77, state its findings as to the causes of the said accident and as to the person or persons, if any, responsible therefor and suggest safeguards against similar accidents in future. The Government also

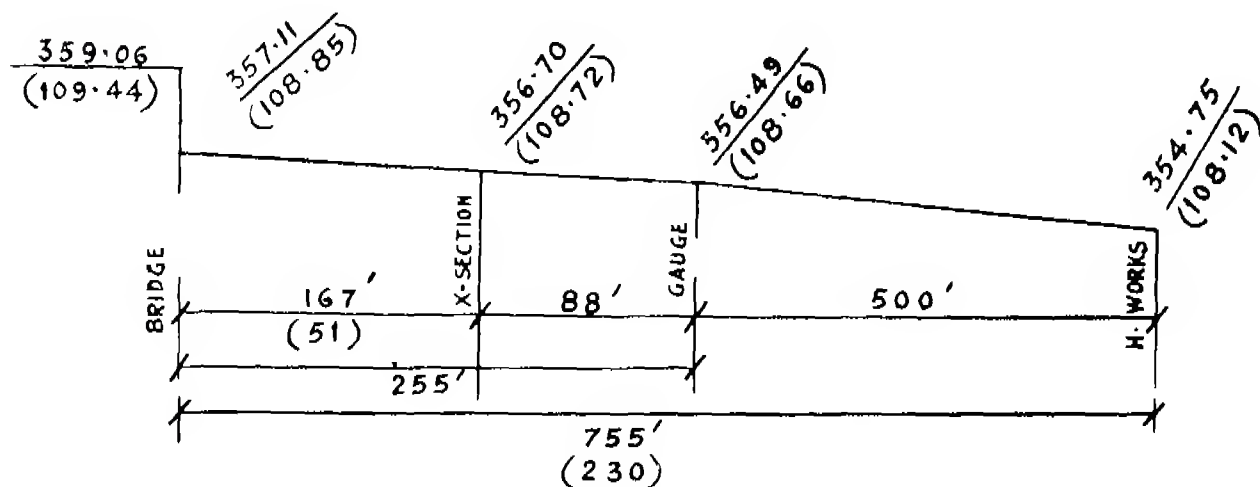
| H.F.L. d/s of Bridge at the gauge location | = | 108.66 | 356.49 |
| Fall of water level = H | = | 0.78 m | 2.57 ft. |

$$\begin{aligned}
 h_1 &= 1.95' \text{ and } h_2 = 0.62 \\
 H &= h_1 + h_2 = 2.57' \\
 S &= \frac{0.62}{255} = \frac{1}{411} \quad \sqrt{S} = \frac{1}{20.18}
 \end{aligned}$$

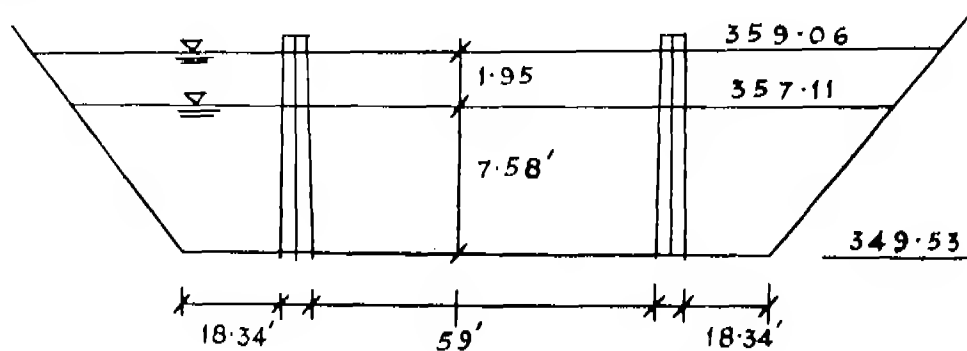
| | Metres | Feet |
|--|---|---|
| (Based on calculations by Shri Suryanarayana, Addl. C. E. Ex : 43) | | |

Area at RL 357.11

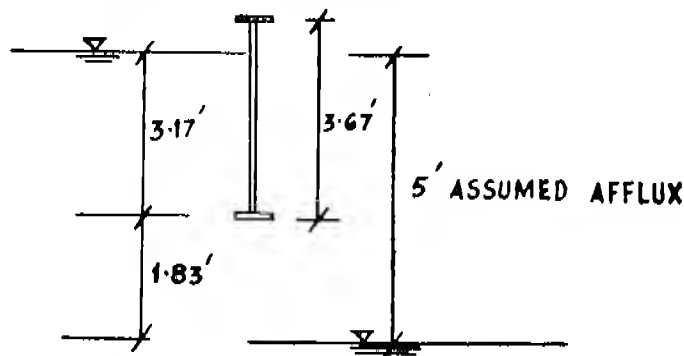
The H.F.L. is $6.06 - 2.39 = 3.17$ ft. above the bottom of the girder.
